# ULTIMATE SECURITY

**The Double Hung 401SH and Single Hung 411SH Windows are virtually break-in proof. After 44 minutes (accumulated) with hand and tool manipulation, the patented center lock made it impossible for entry.**  
(See pictures inside).

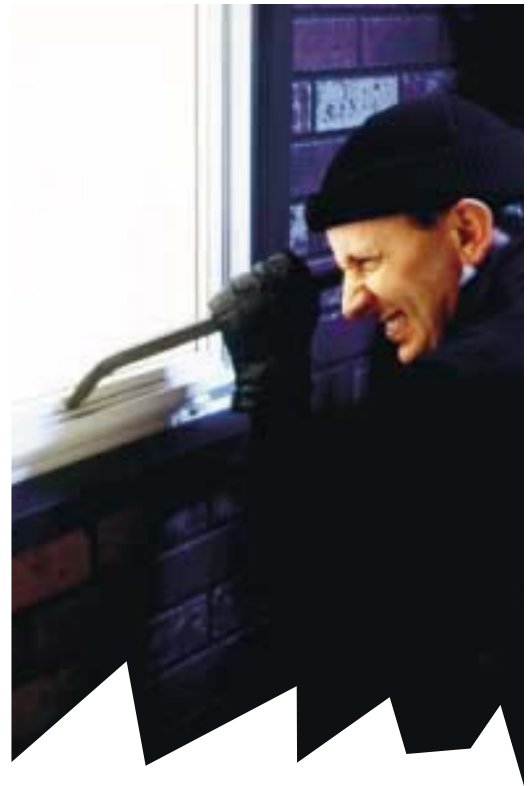
The “Parallex Center Lock” is the key to the high security. The window has a minimum 3 point lock system to a maximum of 5 locks depending upon the size.

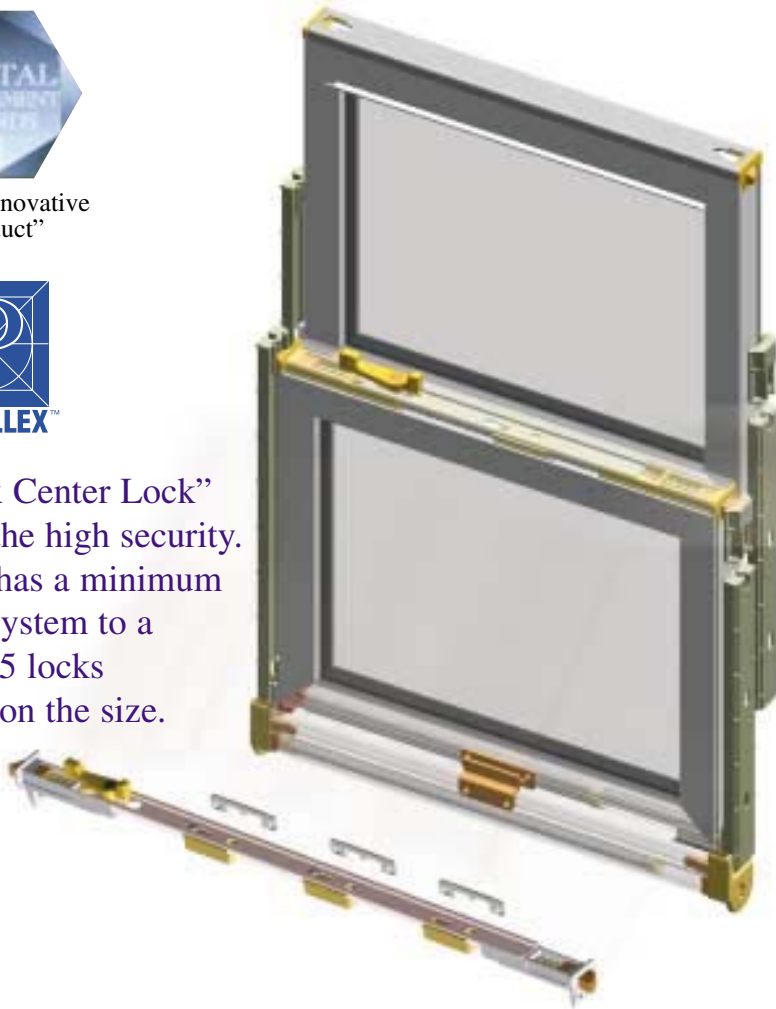
Extra deep engineered resin shoot bolt keys reinforce the sash and frame resulting in unprecedented strength. In addition to multiple cam locks, the bolts prevent the window from being pried open.

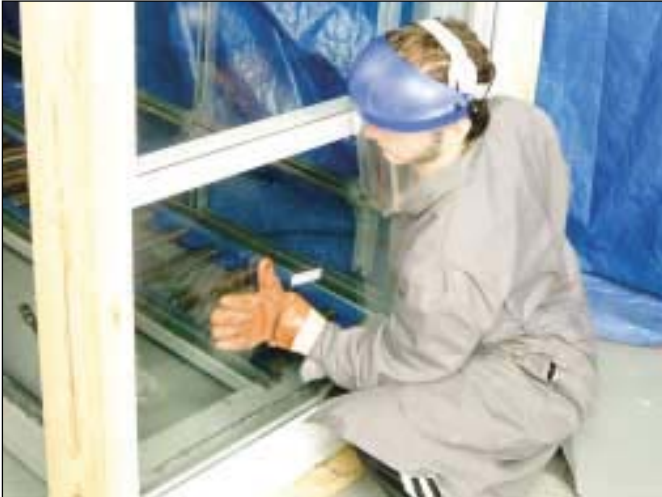
**TEST 1**

**HAND MANIPULATION (T1)**

This is the 1st of 8 tests performed in the lab. The lab technician tried to break in for 10 minutes, by pushing on the glass and frame and sash using tremendous force with his hands and body weight. The sash did not slide at all.

Result: Unable to break in.  Pass  Fail

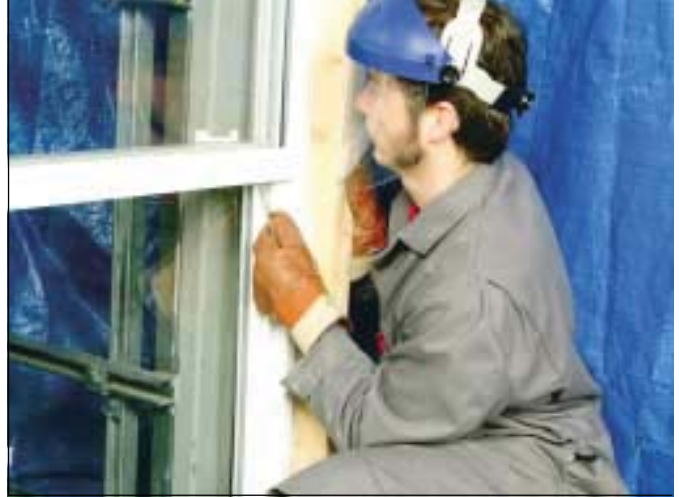
**TEST 2**

**TOOL MANIPULATION (T2)**

The next test involves the lab technician using 3 tools (screwdriver, coat hanger, flexible knife) for 10 minutes. The technician pries, turns, scrapes, twists, and jams the tools, trying to fail the locks.

Result: Unable to break in.  Pass  Fail

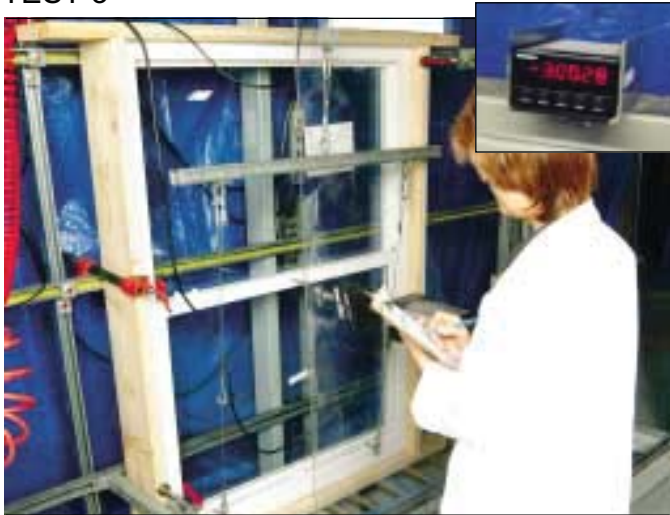
**TEST 3**

**LOAD (L1)**

The window is then clamped securely in the Load machine. Two cables, with a pulling force of 300 lbs. (1334N), try to pull the bottom sash upwards from the frame for 1 minute. The window recorded an impressive meter reading.

Result: Unable to break in.  Pass  Fail

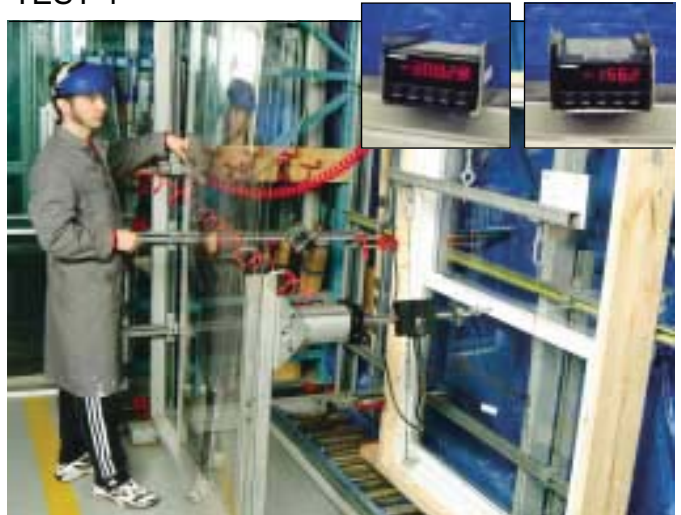
**TEST 4**

**LOAD (L1 + L2)**

With the same cables from Test 3 still attached, a third cable is now attached to the centre of the window and also pulled inward for 1 minute with a force of 150 lbs. (667N). The lab technician attempted to bend or break the sash and/or damage the locks. No damage was visible.

Result: Unable to break in.  Pass  Fail

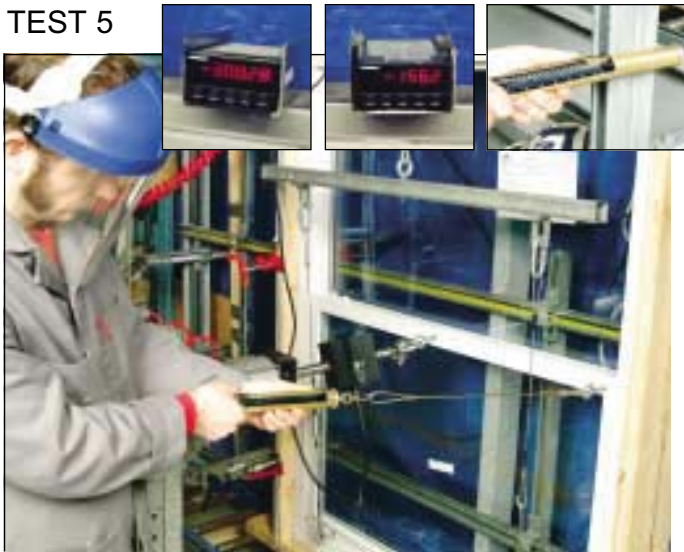
TEST 5

**LOAD (L1 + L2 + L3)**

With all 3 cables still attached from Tests 3 and 4, a fourth cable is attached to the right side of the window and also pulled inward for 1 minute with a force of 65 lbs. (289N). The lab technician again attempted to damage or break the frame and/or locks. No damage was visible.

Result: Unable to break in.  Pass  Fail

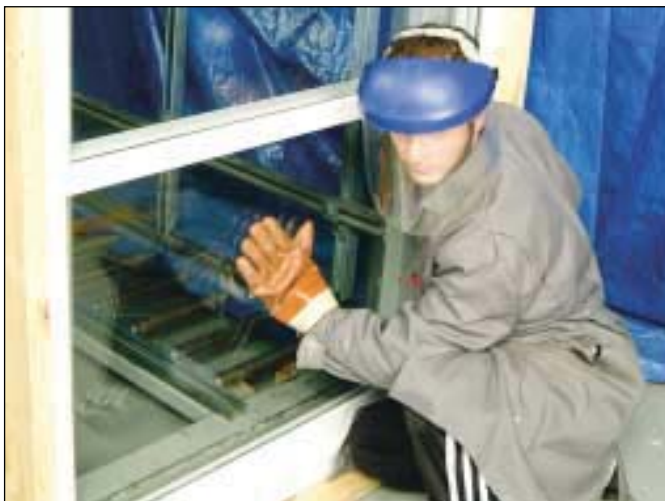
TEST 7

**HAND MANIPULATION (T1)**

At this point, the window has undergone a tremendous amount of stress as a result of the 5 cables pulling in all directions with high loads applied. Test 7 involves another 10 minutes of Hand Manipulation (repeat of Test 1). Again, the lab technician was unsuccessful in his attempt to damage the window.

Result: Unable to break in.  Pass  Fail

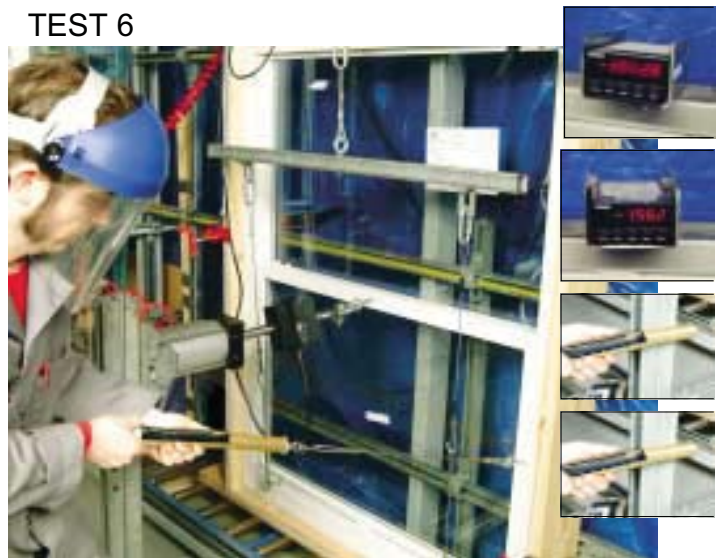
TEST 6

**LOAD (L1+ L2 + L3 + L4)**

A fifth cable is then added (all cables from Tests 3, 4, and 5 are still attached) to the right centre of the window and also pulled upwards for 1 minute in an attempt to move the sash out of the frame. The sash did not move at all.

Result: Unable to break in.  Pass  Fail

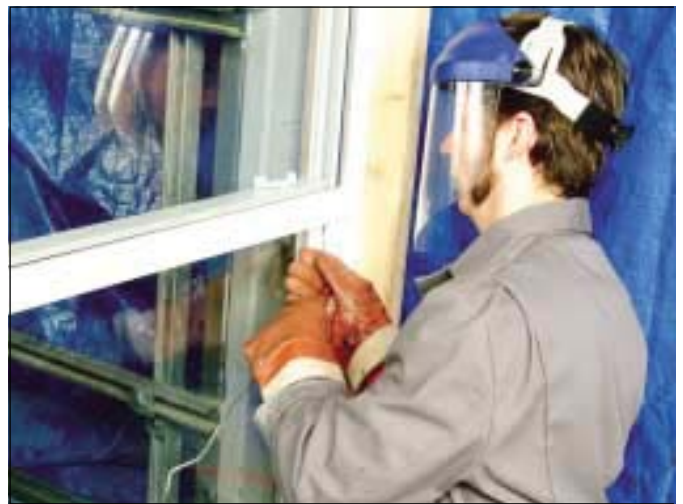
TEST 8

**TOOL MANIPULATION (T2)**

The Final Test involves another 10 minutes of Tool Manipulation (repeat of Test 2). Here, the lab technician uses a screwdriver, coat hanger, and flexible knife against the frame and sash to attempt to persuade the window to allow him entry. Again, the lab technician was unsuccessful in his attempt to break in.

Result: Unable to break in.  Pass  Fail
